Re: Notice of Violation
Compliance Evaluation Inspection
ILD 005 070 495

Photographs for EMCO Chemical Distributor CEI 7/23/15

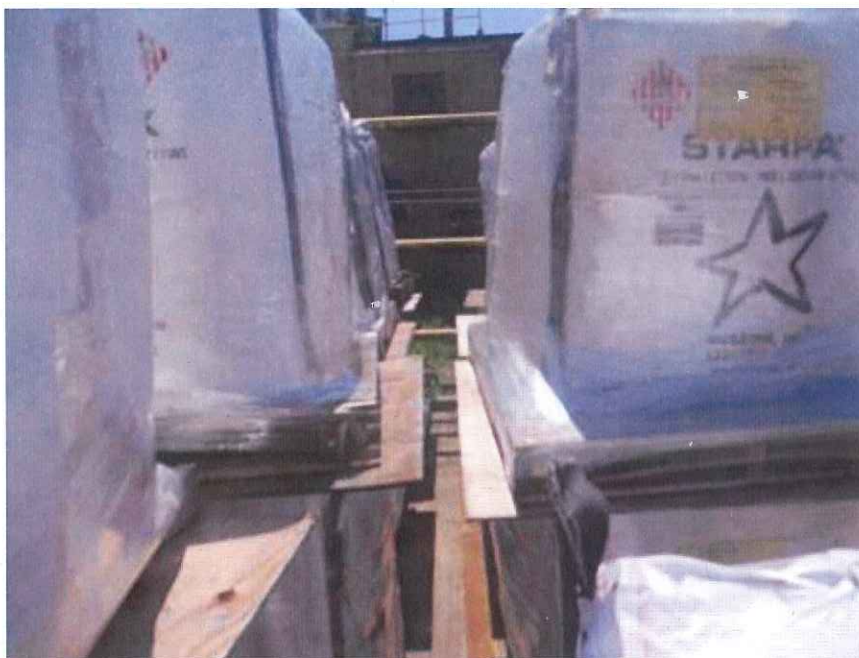
Waste Pad Storage Area. Totes of hazardous waste from the laboratory were being stored in this location on pallets. Aisle space was too small for me to fit through to check all of the labels.

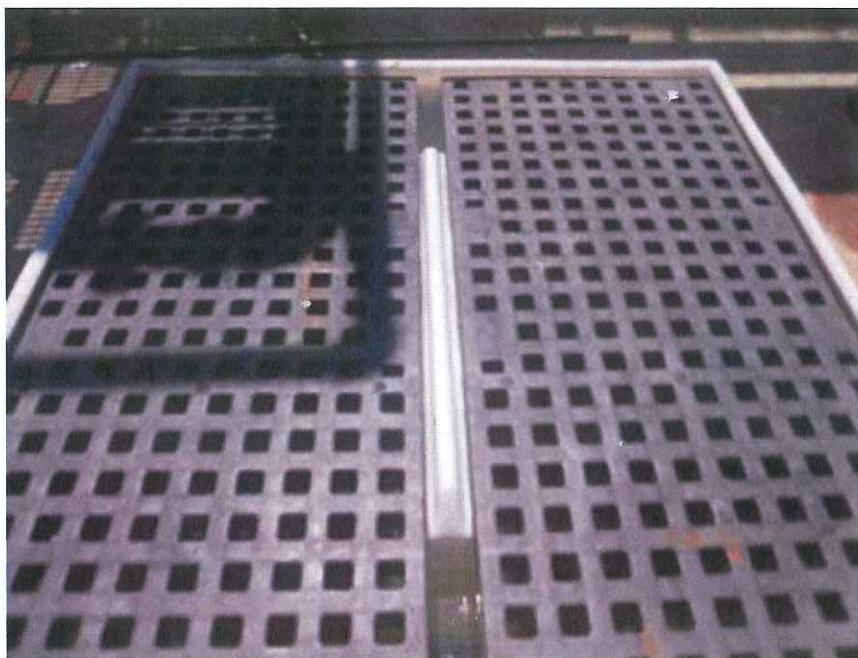
Waste Pad Storage Area. Grated pallet used for storage and collection of spills.

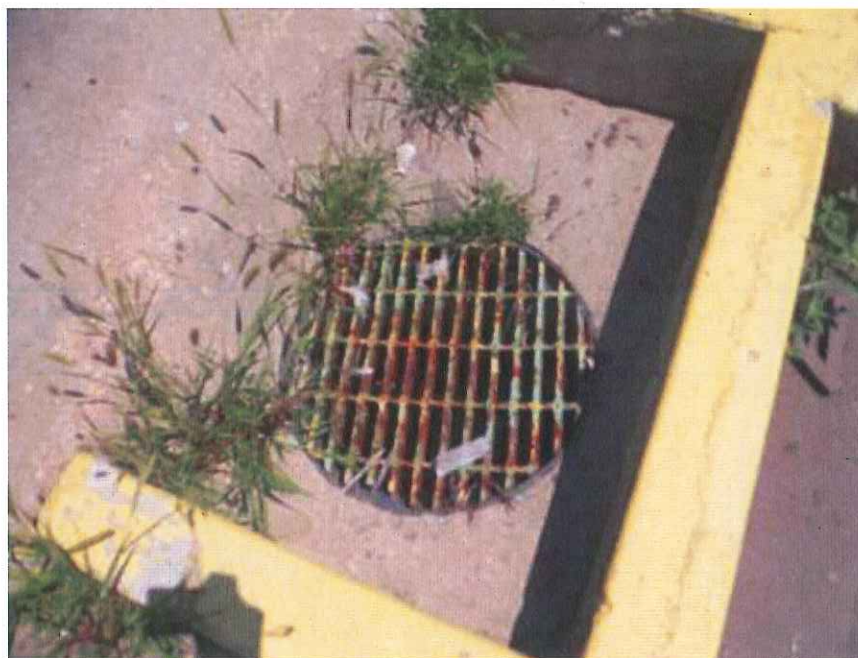
Disk Number 1
Photo Number 42
Photo Filename DSCN0897.JPG
Date/Time 7/23/2015
12:43:00 PM
Photographer Jamie Paulin

Pit located outside in the Waste Pad Storage Area. The pit collects rain water and is present in case of a spill. Periodically Emco collects the material in the pit.

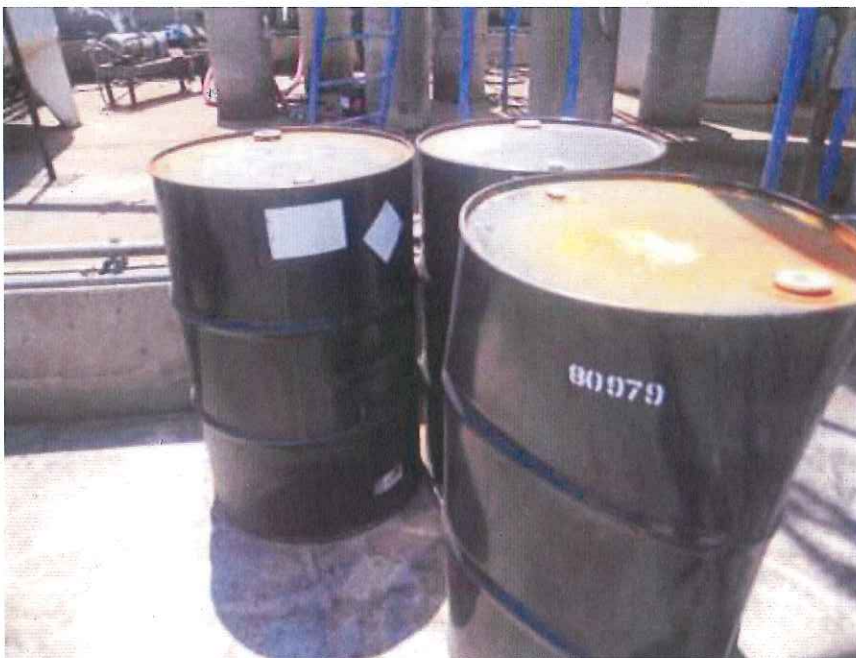
Waste Pad Storage Area. Three 55-gallon containers of wash solvent that Emco will either re-use or sell.
